# Fairfield Betula Limited

## Dunlin DFGI/DPI Decommissioning Programme Regulatory Close Out Report

Document number	FBL-DUN-DUNA-HSE-01-RPT-00008-01
Revision	A3
Date	18 <sup>th</sup> Jan 2021

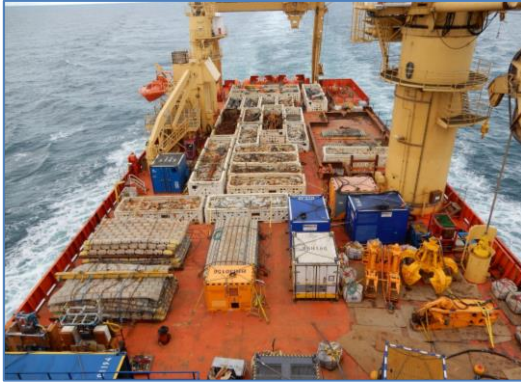
**Debris Recovery**

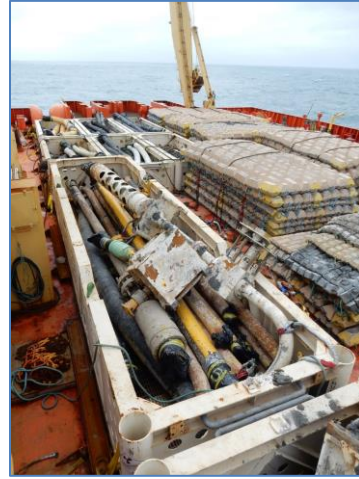
**Infield Jumpers and Flowlines Recovered**

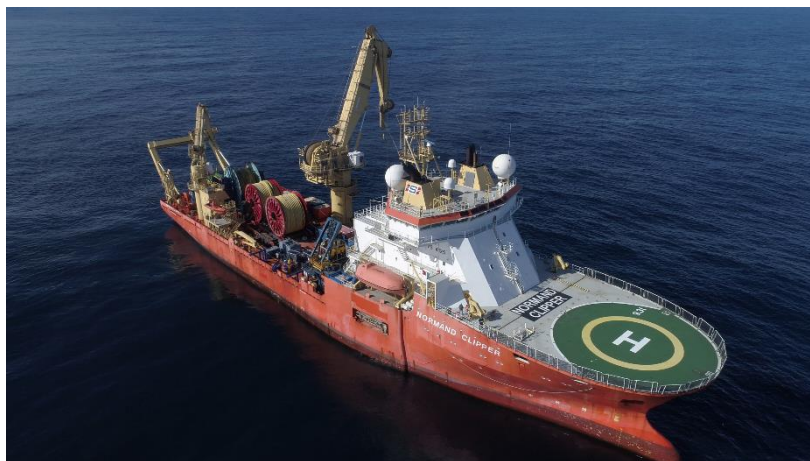
**Normand Clipper Reverse Reeling**

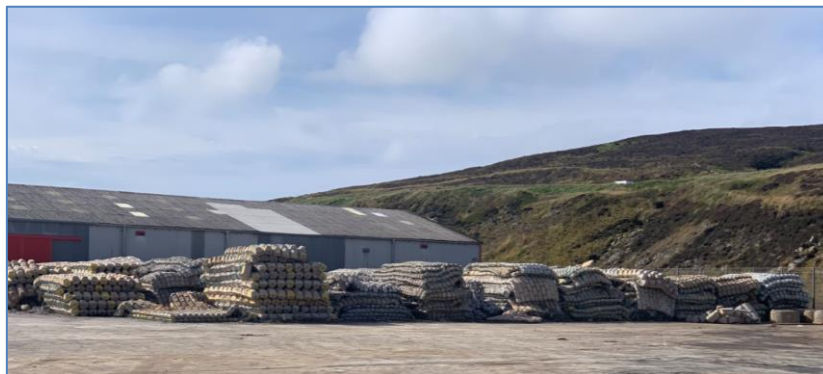
**Mattresses Recovered from Osprey, Merlin and Dunlin**

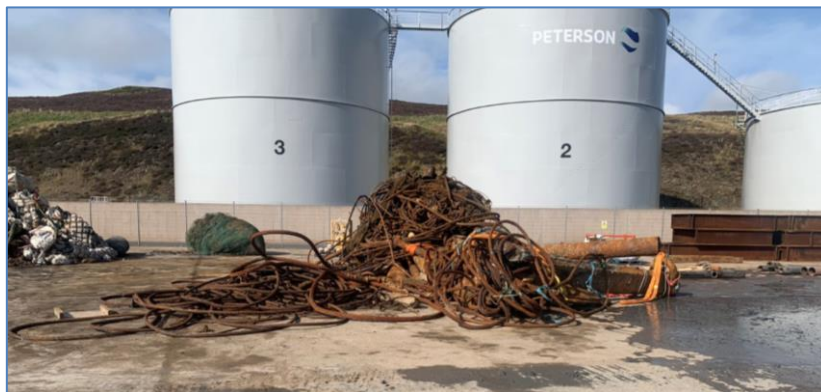
**Wire Debris & Fishing Debris Recovered**

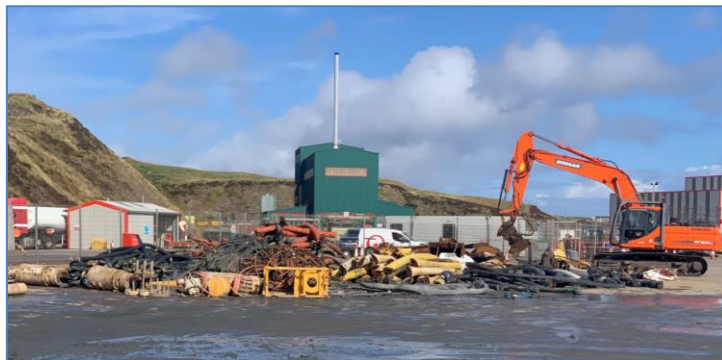
**Waste Preparation & Separation**

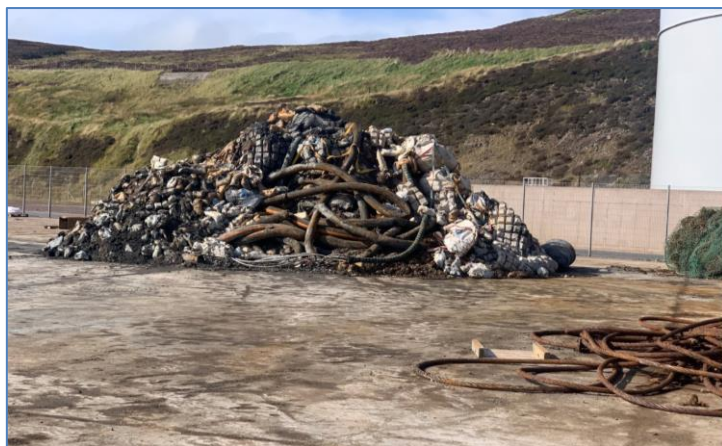
**Mixed Sand / Grout / Mattress Deposits Recovered for Landfill**  
(Note flexible hose and umbilical were not recovered by Fairfield)

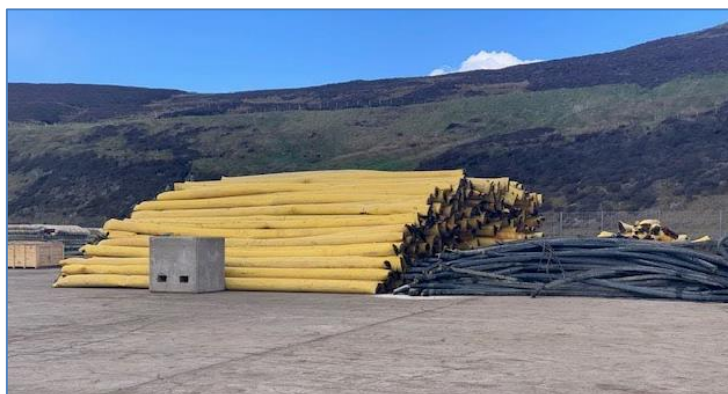
**Flexible Pipeline and Umbilicals Prepared for Transport to Recycling Facility**
