Fairfield Betula Limited

Dunlin Alpha Topsides Decommissioning Programme Regulatory Close Out Report

Document Number	FBL-DUN-DUNA-HSE-01-RPT-00012-01
Revision	A3
Date	19/09/24

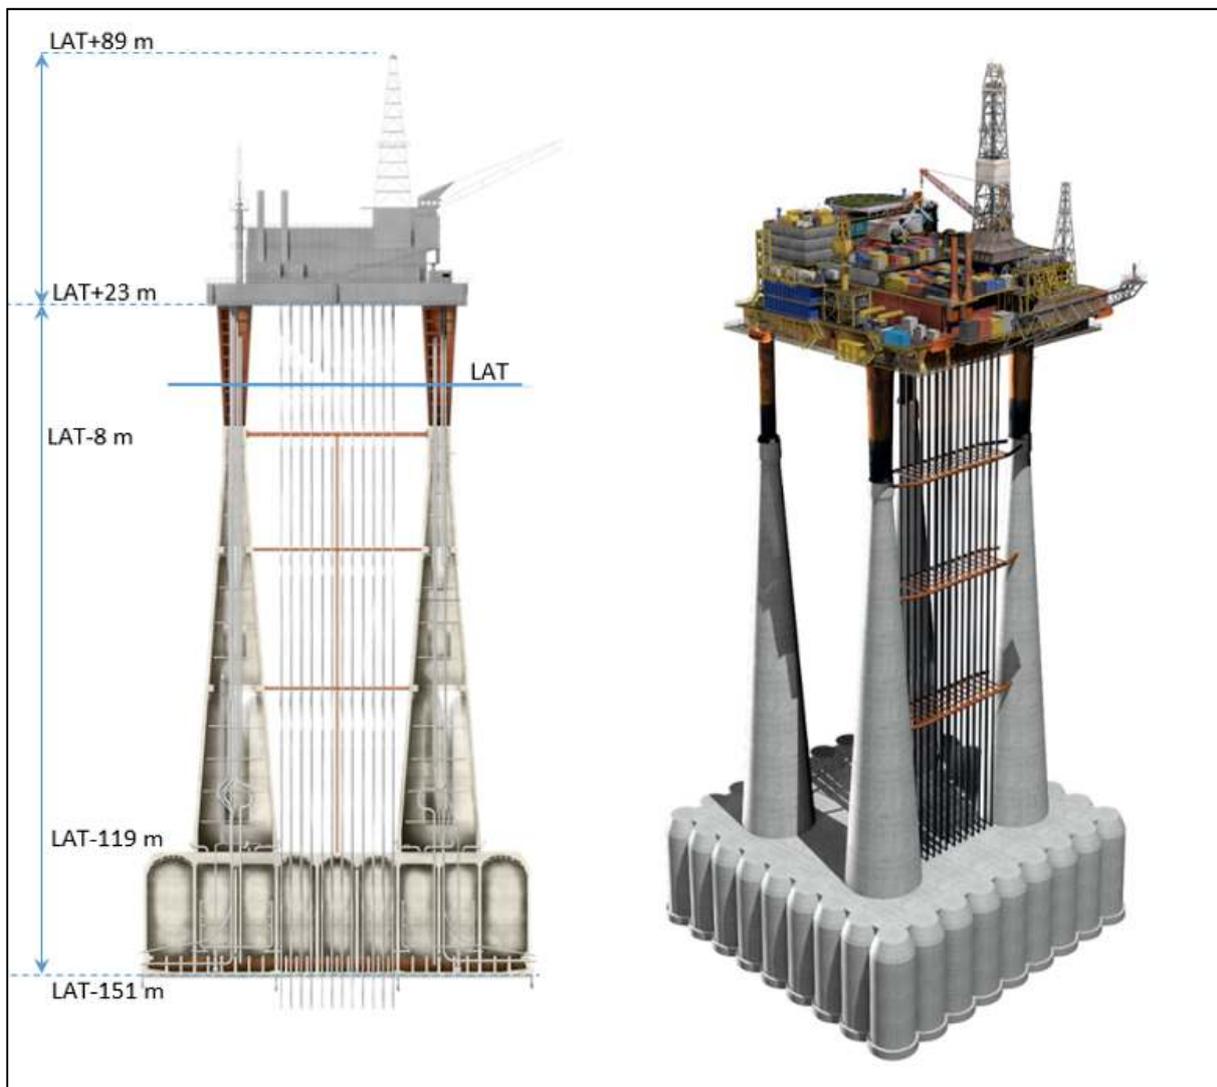
Figure 1-1: Dunlin Alpha South and South-West Elevations

Dunlin Alpha consisted of a four leg Concrete Gravity Base Substructure (CGBS), herein referred to as the substructure; a steel box girder Module Support Frame (MSF) deck; and two further levels of modules. The installation stands in 151 m of water with concrete legs extending to 8 m below Lowest Astronomical Tide (LAT) and steel transitions spanning the splash zone to approximately LAT+23 m. These transitions previously carried the installation topsides, with the top of the drilling derrick 240 m above the seabed as shown in Figure 1-1.

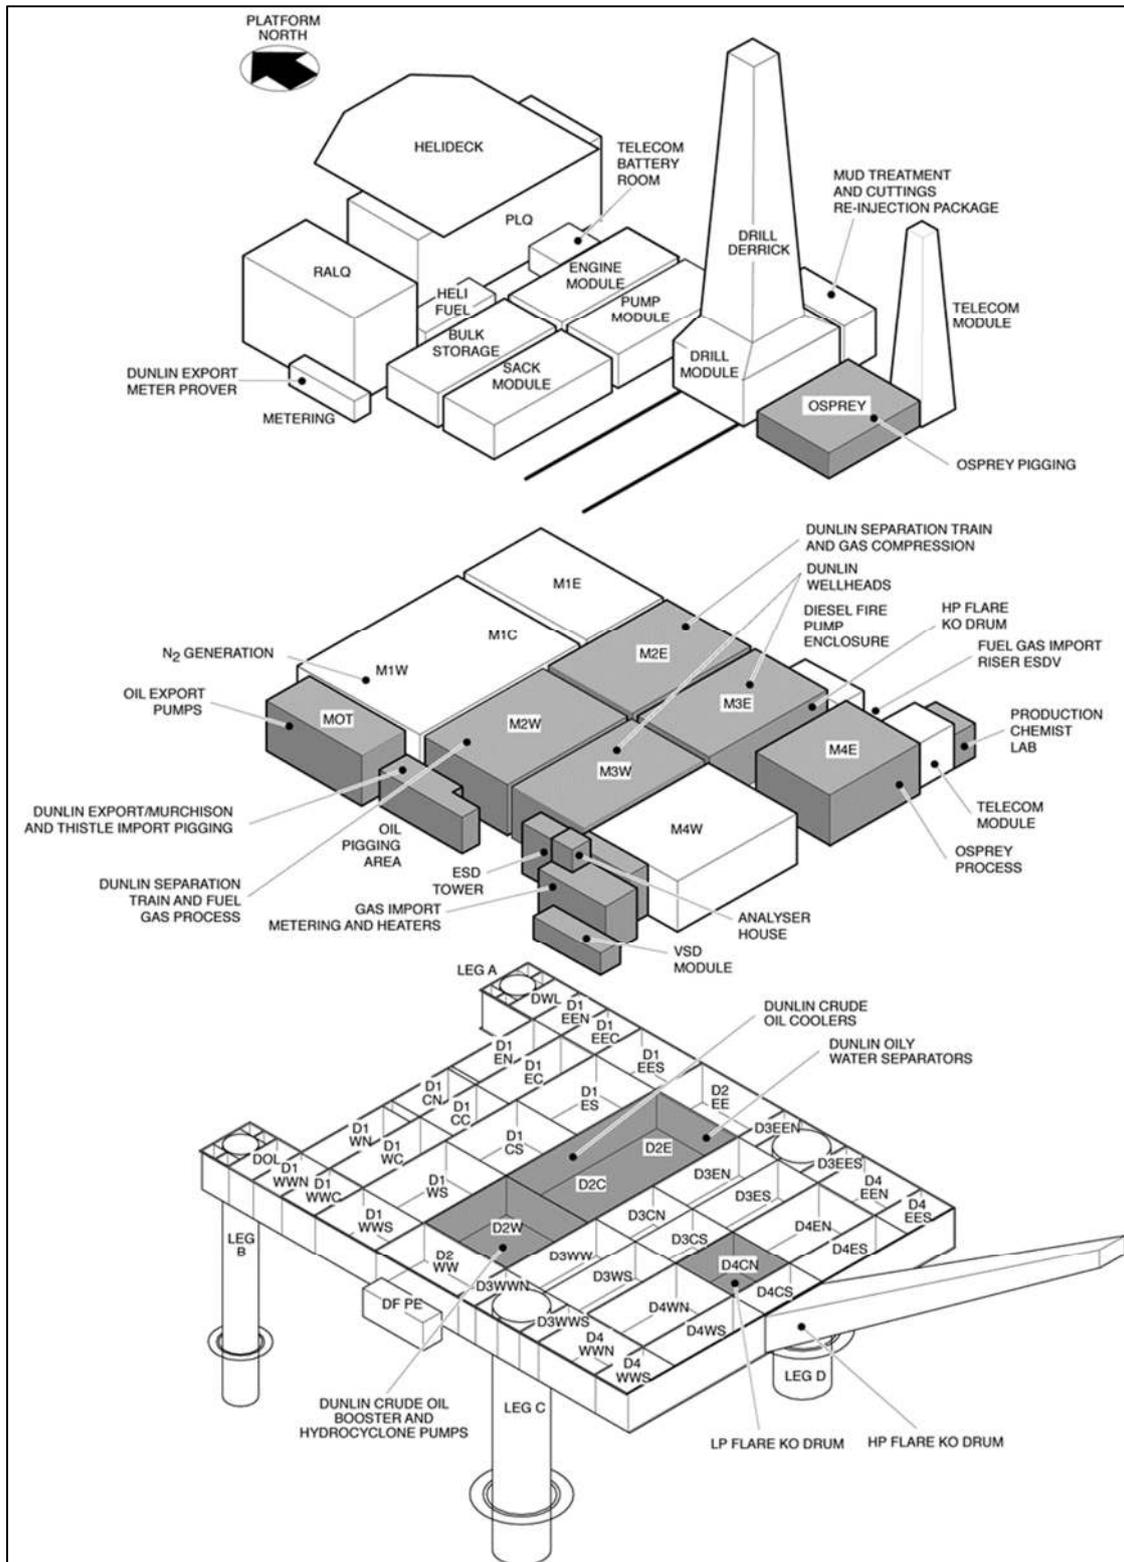
Figure 1-2: Dunlin Alpha Topside Modules

The Dunlin Alpha topsides were designed as an integrated drilling and production facility as shown in Figure 1-2. These topsides have now been fully removed by optimised reverse installation for onshore recovery and disposal, in accordance with the Oslo and Paris Convention (OSPAR) Decision 98/3 and as described in the approved Decommissioning Programme. The Dunlin Alpha substructure is a candidate for derogation under Decision 98/3 and, as of 2Q'24, the Decommissioning Programme for the substructure is still under consultation with OSPAR Contracting Parties.

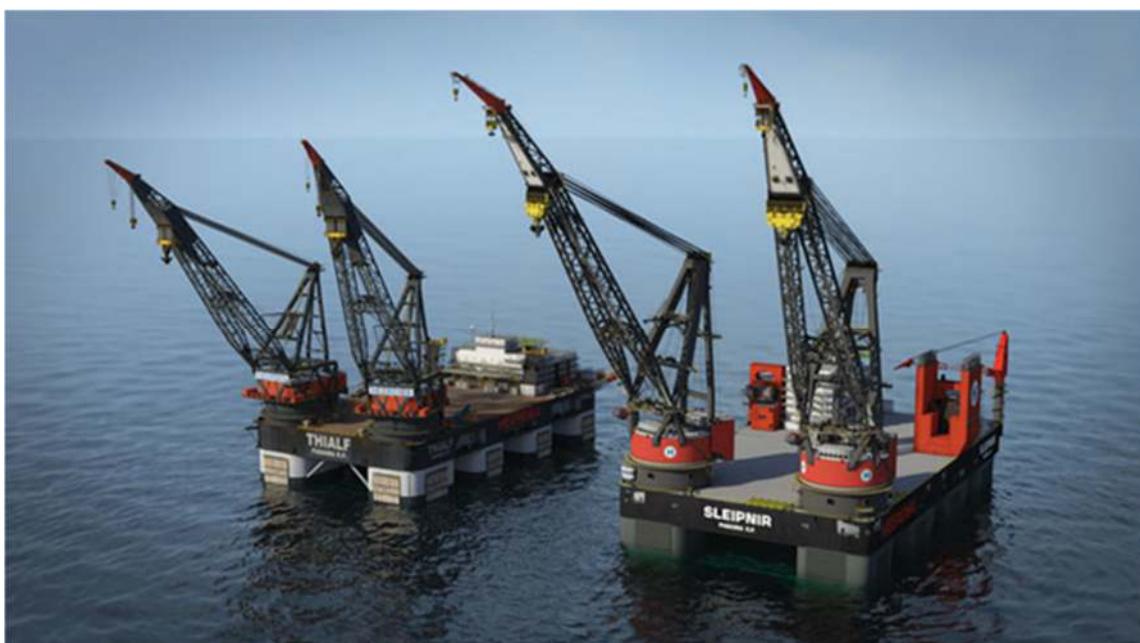
Figure 2-1: Semi-Submersible Crane Vessels *Thialf* (left) and *Sleipnir* (right)

The first phase would be conducted using the Semi-Submersible Crane Vessel (SSCV) *Thialf*, from which the majority of the preparation work would be conducted and a number of platform modules would be removed. This would be followed by a campaign utilising HMC's newly commissioned (July 2019) SSCV *Sleipnir* (see Figure 2-1) to remove a number of remaining modules and to then lift and transport the platform MSF to the nominated disposal yard in Vats, Norway.

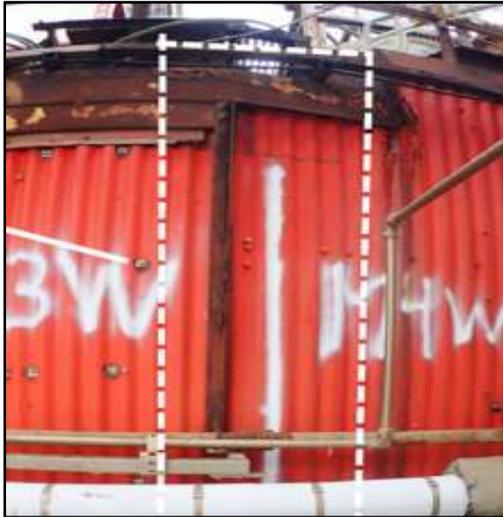
(a) Preparations for Module Separation

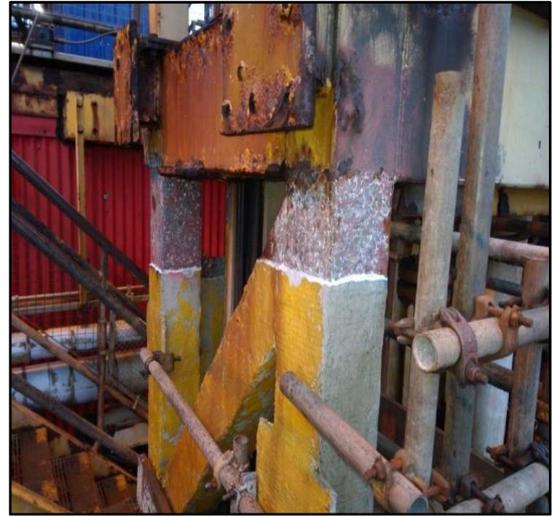
(b) Investigation of PFP Ceramic Fibres

As part of the verification of technical information process, HAF investigated a number of locations containing Passive Fire Protection (PFP). It was found that the PFP at four of these locations contained Refractory Ceramic Fibres (RCF). These fibres are generally well bonded to PFP material so pose very low risk of exposure to personnel whilst *in situ* offshore. However, the removal contractor would be required to remove portions of this PFP at areas local to any offshore cutting (necessary for removal of platform modules) which would cause the RCF to become more friable. A number of additional work controls, similar to those for asbestos removal, were required to be put in place in order to facilitate the safe removal of PFP at such locations. Similar additional controls were also required at the disposal site. This had an impact on the agreed project cost. It is recommended for future projects that all PFP is tested not only for asbestos, but also for RCF, to ensure that the full hazardous material inventory is identified in advance of the competitive tender process.

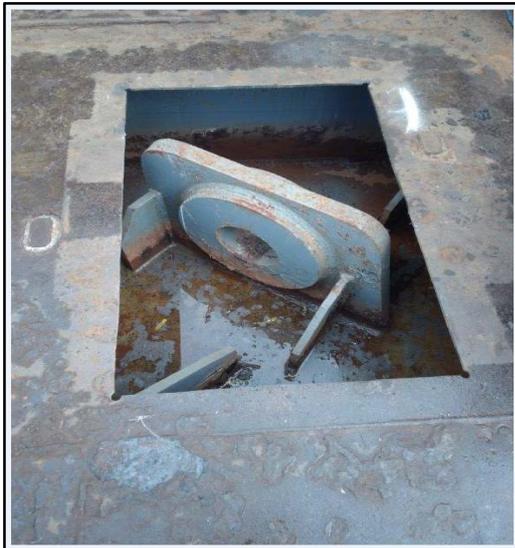
(c) Installation of Module Lift Points

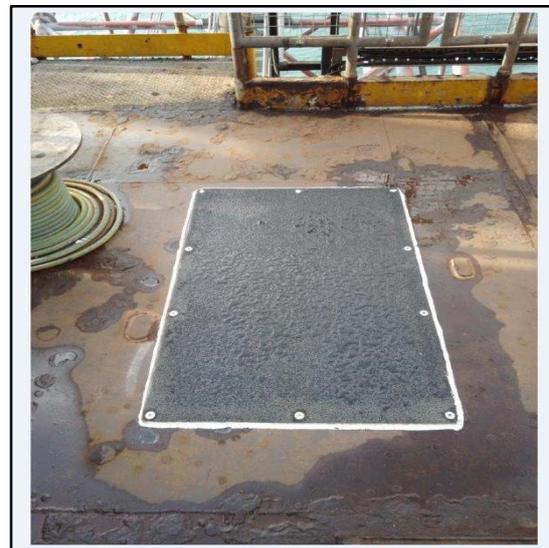
(d) Deck Reinstated over Lift Points

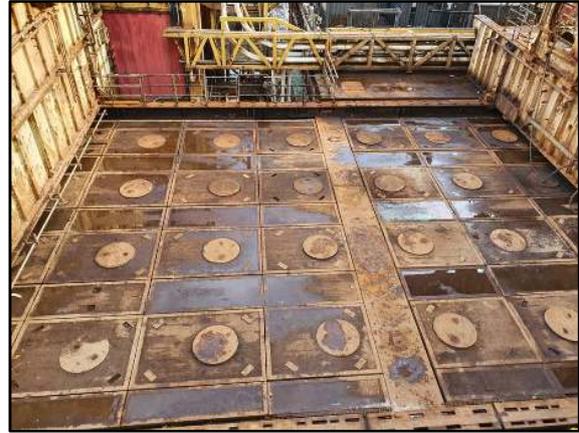
(b) Well Bay Cleared for Cold Stack

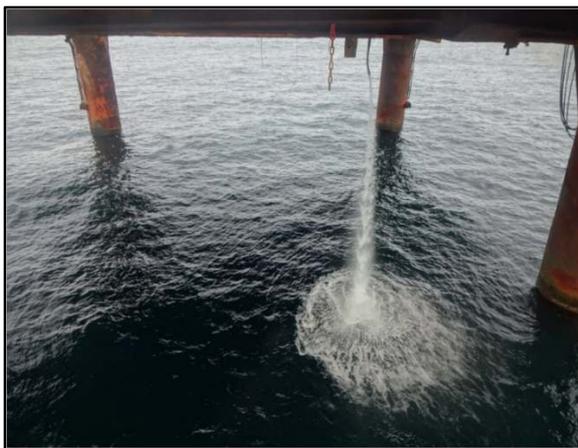
(c) Air Gap Cleared of Conductors

By summer 2021, the majority of the well conductors had been removed to 74 m below LAT (a level just above the lowest of the guide frames). Although air-gapped, six conductors remained at a higher level for future subsea removal due to the presence of clamps on their lower sections. Maersk Supply Services had been contracted to undertake this conductor recovery scope and evaluated the use of shaped explosive charges as a potential cutting solution which, following onshore trials, was ultimately determined to carry too much execution risk for adoption.

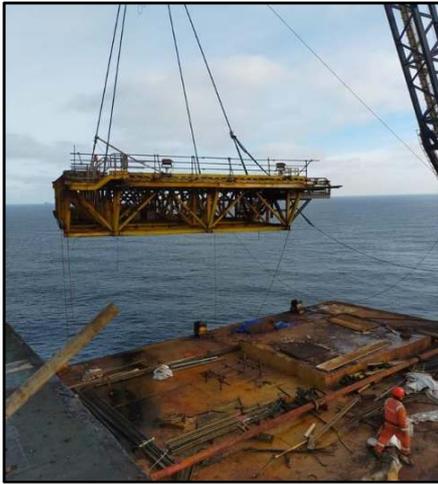
(a) East Helideck Removal (by *Thialf*)

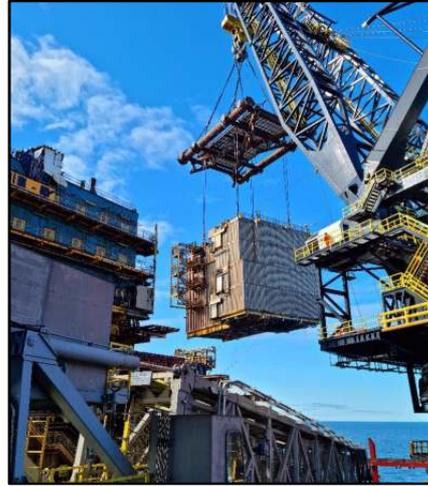
(b) RALQ Removal (by *Thialf*)

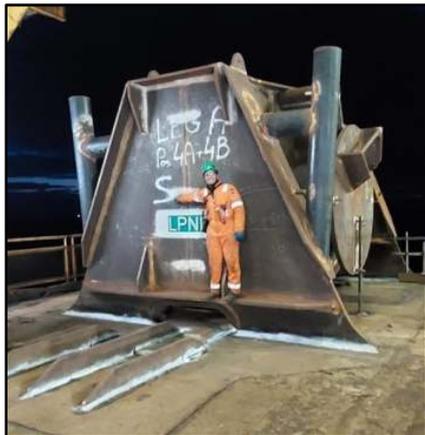
(c) MSF Lift Point Installed at Leg A

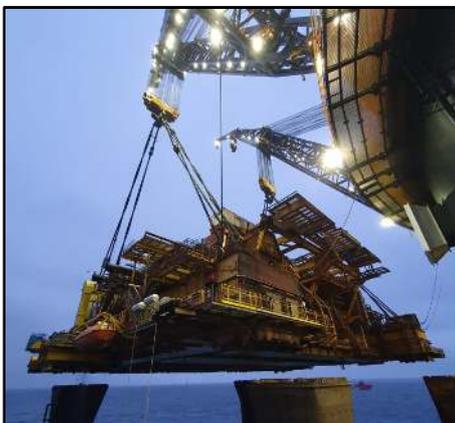
(e) MSF Lift (by *Sleipnir*)

Upon safe completion of the circa 12,500 mT lift of the MSF, *Sleipnir* repositioned itself and installed the permanent Navaid onto Dunlin Leg D. *Sleipnir* then departed the Dunlin location with the MSF suspended in the dual cranes of the HLV for the duration of the transit to Vats, Norway. Upon safe arrival at Vats, *Sleipnir* completed the load-in of the Dunlin MSF and the five remaining modules, thereby completing the offshore execution scope of work. All planned HLV Campaign #2 objectives had been achieved, ahead of the HAF schedule and within FBL budget.

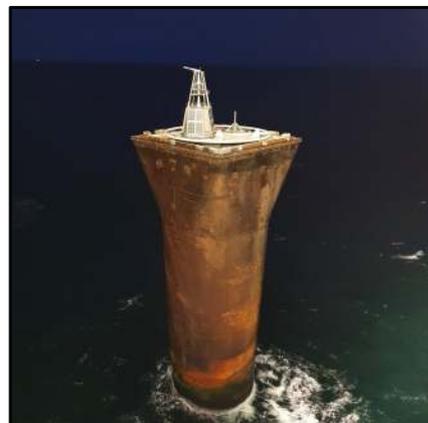
(f) Navaid Installed on Leg D

The solar-powered, self-contained offshore lighthouse, installed as an Aid to Navigation (AtoN) on one of the legs of the remaining substructure, failed in January 2022 and January 2023. Both failures rectified themselves some weeks later, suggesting that the unit simply had insufficient battery charge to support its full functionality. While it is not possible to be certain of the cause until the unit has been returned ashore and examined, Fairfield is confident that additional battery capacity will remove this failure mode. The stand-by unit has had additional batteries installed and will be changed out in due course as part of the Substructure Decommissioning Programme.

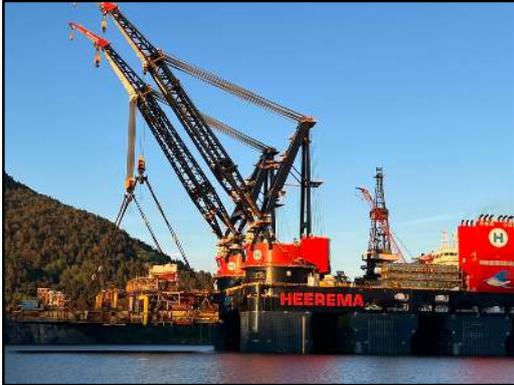
(g) *Sleipnir* in Transit with MSF on Hooks

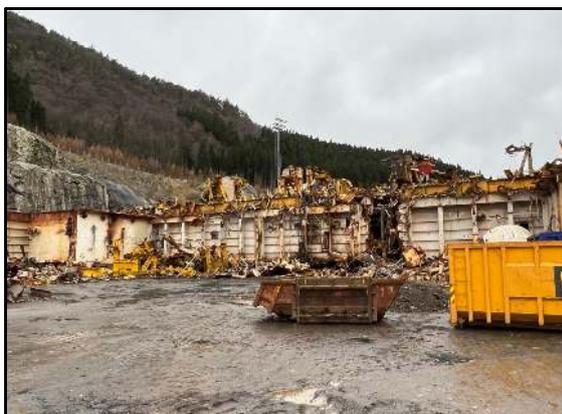
(k) MSF Destruct in Progress

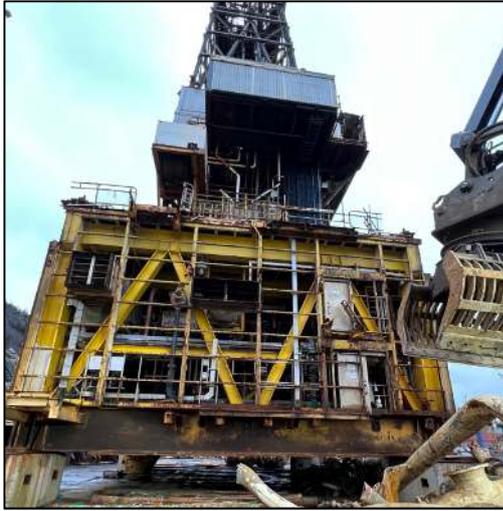
(a) Destruct of Drilling Module

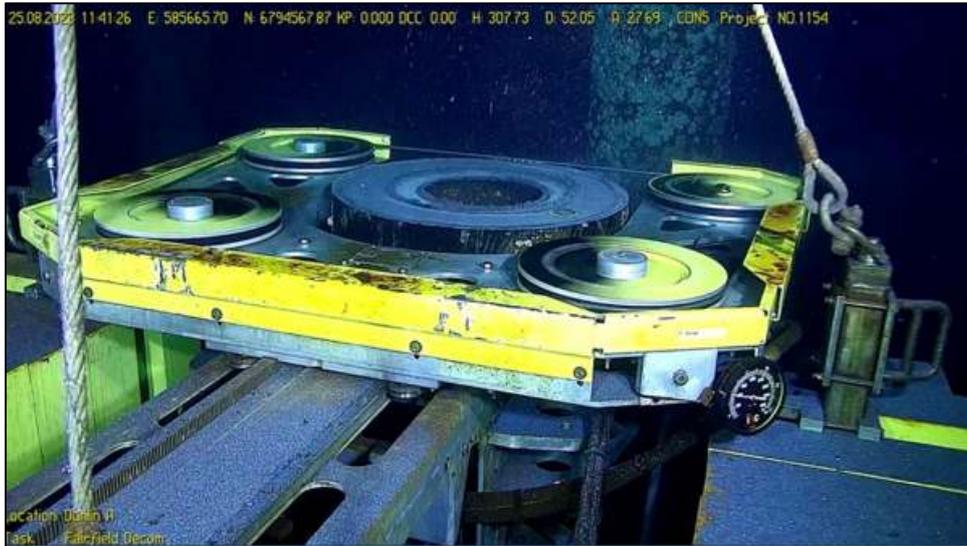
(j) Diamond Wire Cut of DA48 Conductor (Aug'23)

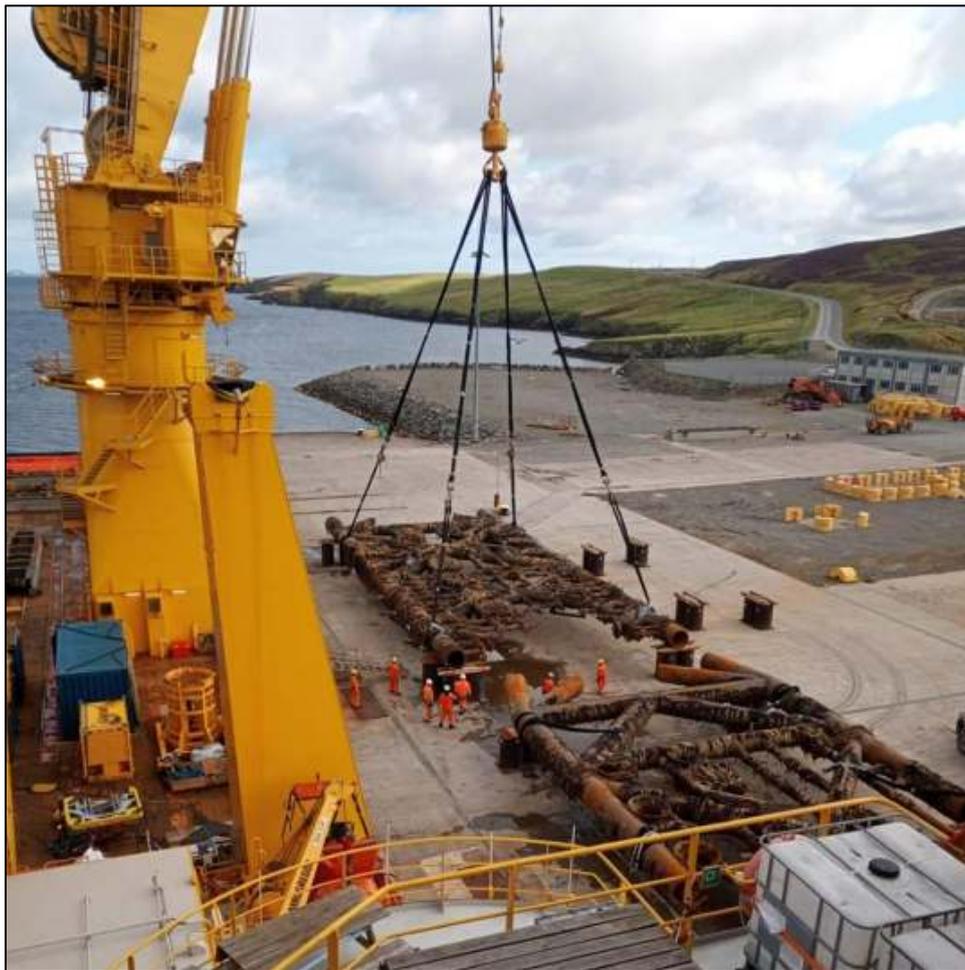
(k) Upper CGF at Dales Voe Yard (Aug'23)

On CGF Removals, Maersk advised Fairfield in February 2023 that it would be unable to perform the scope of work that year due to a damaged crane on its intended execution vessel (CSV Maersk Implementer). Fairfield therefore awarded the scope of work to DeepOcean and the CSV *Edda Freya*. Engineering and procurement activities were completed ahead of mobilisation of the *Edda Freya* in August 2023. Removal of the six remaining conductors and the upper and middle CGFs commenced in July 2023 and proceeded to plan. Work was completed in September, followed by in-load of the removed steelwork to Dales Voe in Shetland.

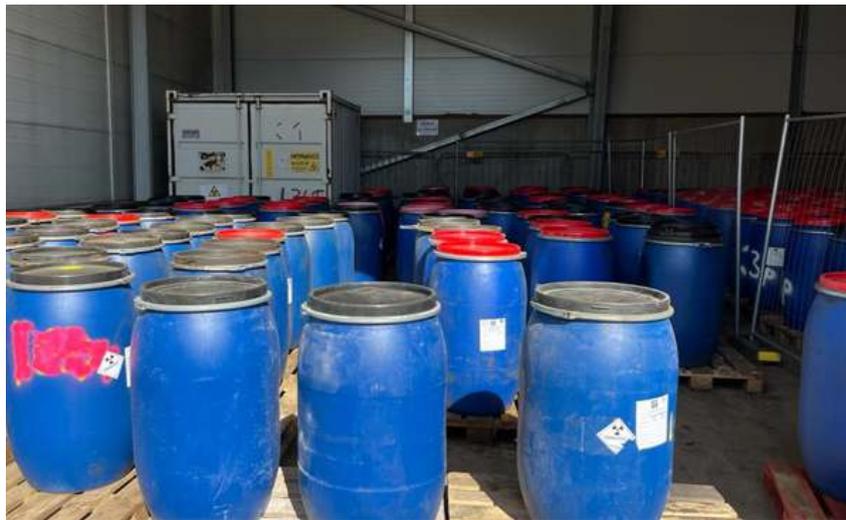
(m) NORM Waste at Vats, Norway

Ultimately, it was determined by the Norwegian *Direktoratet for Strolevern og Atomsikkerhet* (DSA) and the NEA that NORM waste could be managed locally in Norway at the Wergeland-Halsvik underground repository. Due to the need to extend this repository, the physical disposal of the Dunlin wastes is forecast to be completed around year end 2025 and the project undertakes to formally notify OPRED when this activity has been concluded.
