# Fairfield Betula Limited

## Dunlin Alpha to Cormorant Alpha Pipeline (PL5) Decommissioning Programme Regulatory Close Out Report

Document number	FBL-DUN-DUNA-PL5-01-RPT-0001-01
Revision	A2
Date	25/02/2021

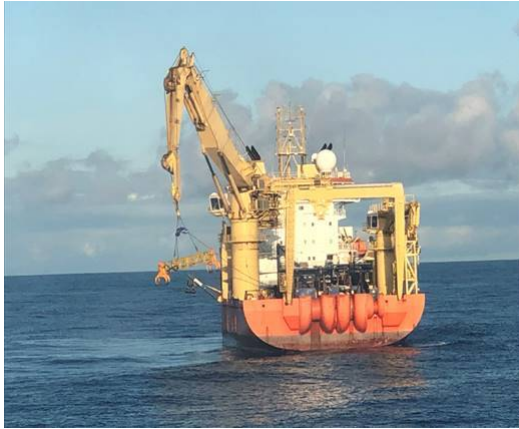
**Normand Clipper Cut Line Recovery**

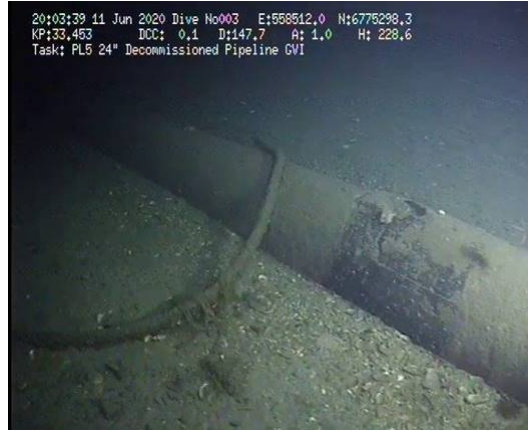
**PL5 Route Debris**

Surveys of the pipeline corridor were undertaken using visual, Side Scan Sonar (SSS) and Multi-Beam Echo Sounder (MBES) techniques. Targets confirmed as oil field related debris or which presented a significant hazard to other users of the sea, regardless of debris type, were removed. In total, 50 targets were identified and removed. On completion of target removal, the area was re-surveyed to demonstrate and verify a clear seabed. Further details can be found in the Site Clearance Summary referenced below.

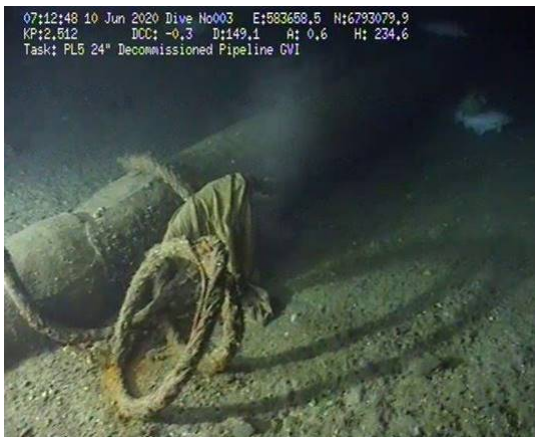
**PL5 Route Debris**

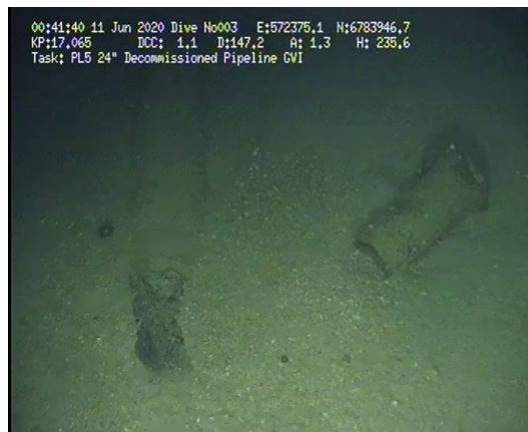
**PL5 Route Debris**

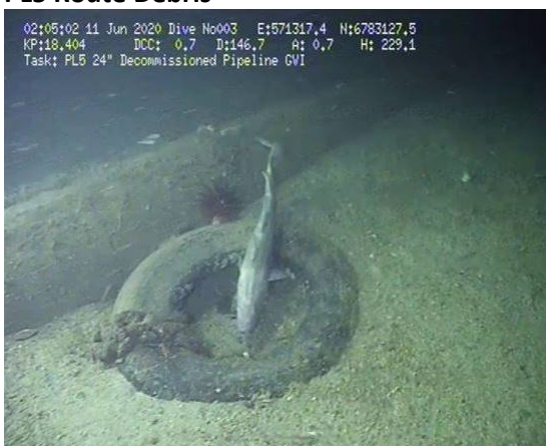
**PL5 Route Debris**

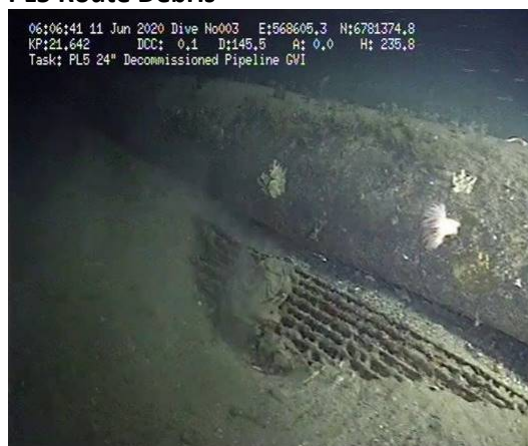
**PL5 Route Debris**

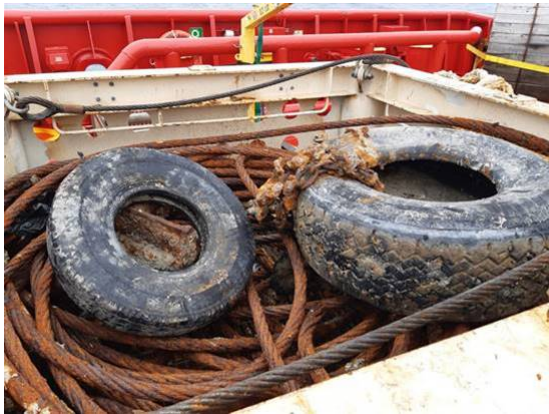
**PL5 Route Debris Recovered to Deck**

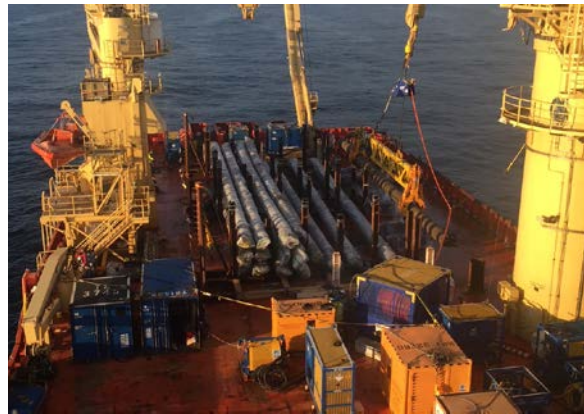
**PL5 Recovery Operations**

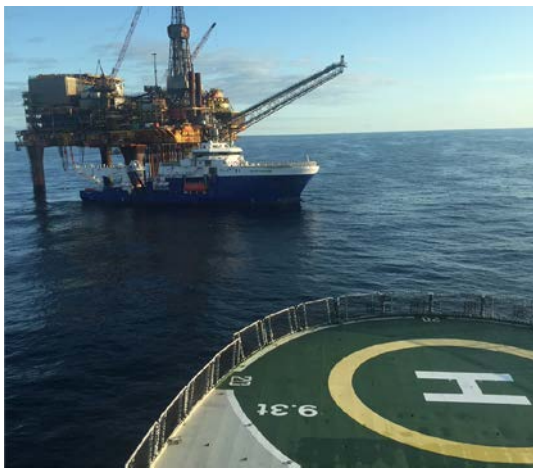
**Rever Sapphire undertaking PL5 Disconnect  
at Dunlin Alpha**

The Dunlin Alpha pipeline to Cormorant Alpha (PL5) has been disconnected from its respective installations.

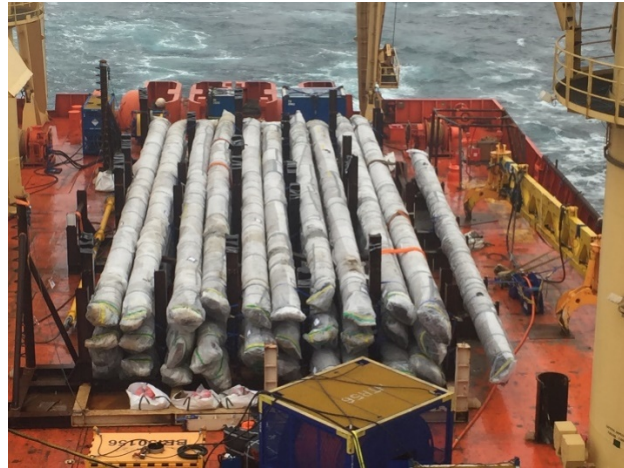
**PL5 Spool Sections Recovered to CSV  
(Asbestos Precautions Visible)**

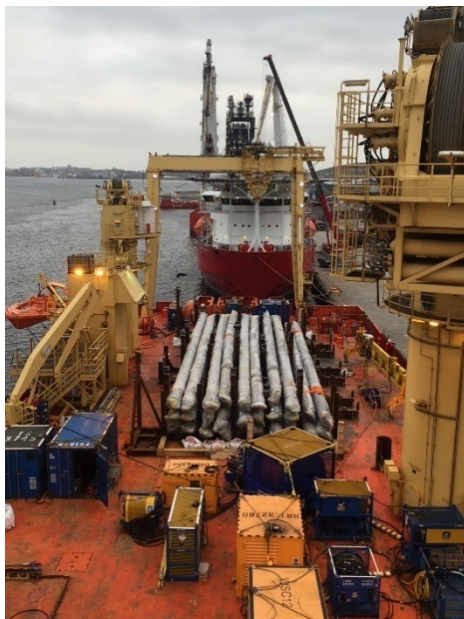
**Discharge of PL5 Sections in Lerwick**

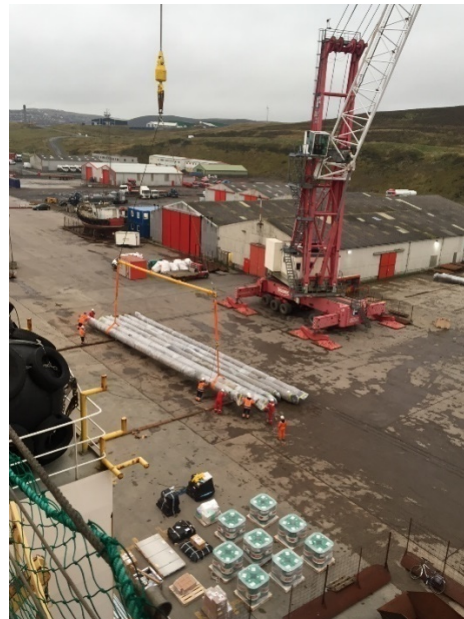
**PL5 Spool Sections on Quayside**

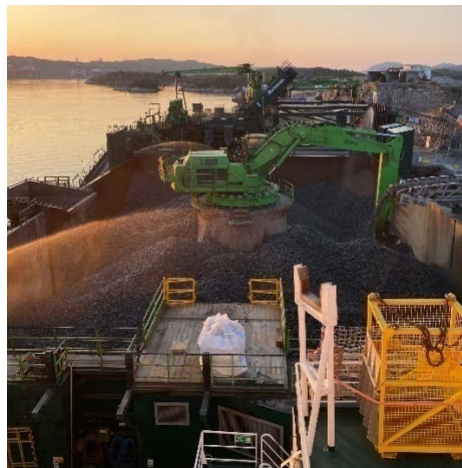
**Rock Loading for PL5 Remedial Operations**

A dynamically positioned fall pipe vessel was mobilised to the PL5 line and installed 19,828 tonnes of rock over 96 locations. Exposed ends, free spans and areas of pipeline crowning were remediated. Rock cover activities were completed 26<sup>th</sup> Aug 2020

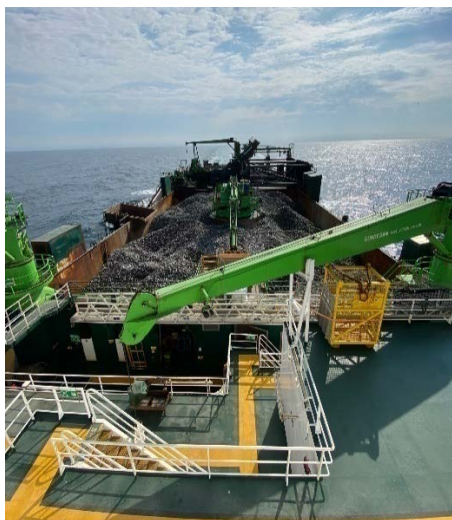
**Rock Placement Operations on PL5**

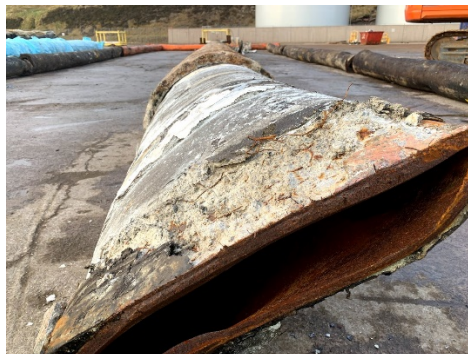
**PL5 cut section**

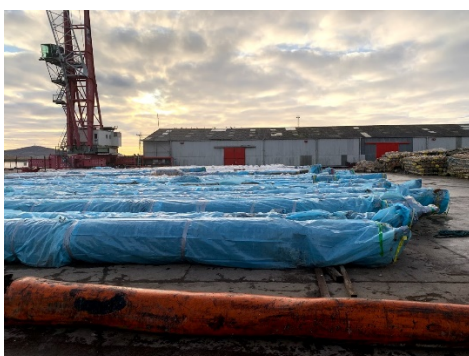
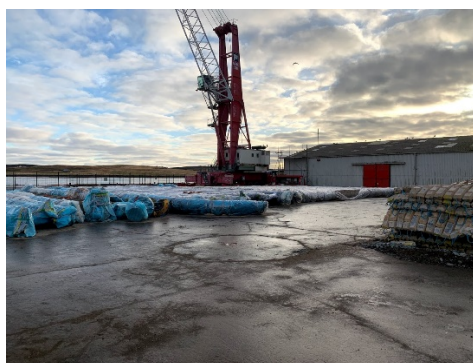
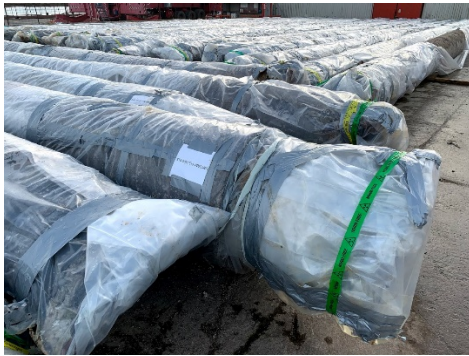
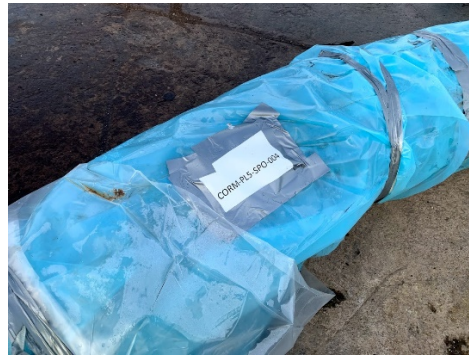
**PL5 pipeline sections for controlled disposal:**
