# Fairfield Fagus Limited

## Merlin Pipelines and Structures Decommissioning Programme Regulatory Close Out Report

<b>Document number</b>	FFL-DUN-MER-HSE-01-RPT-00004-01
<b>Revision</b>	A3
<b>Date</b>	18 <sup>th</sup> Jan 2021

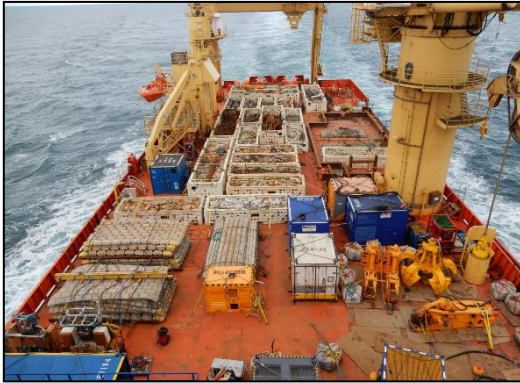
**Debris Recovery**

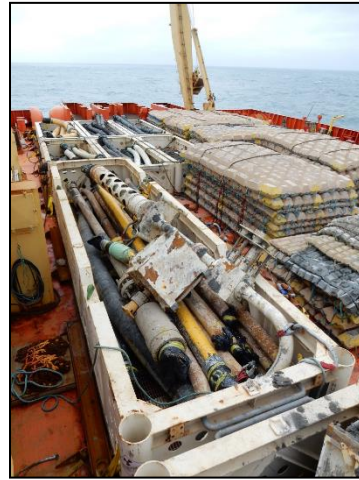
**Infield Jumpers and Flowlines Recovered**

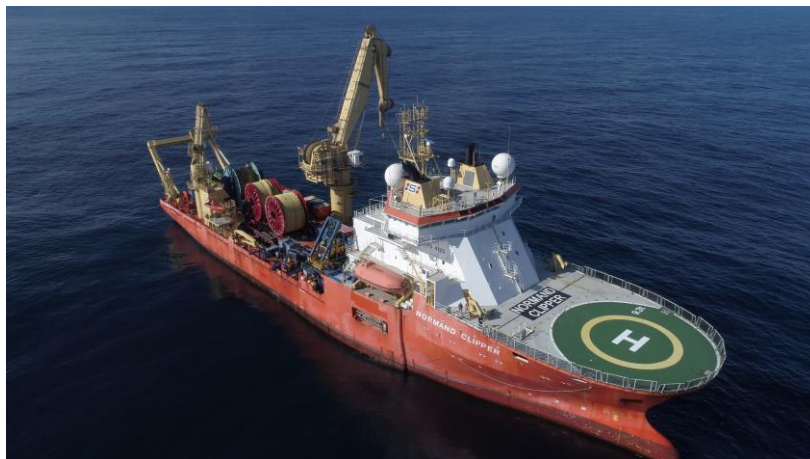
**Normand Clipper Reverse Reeling**

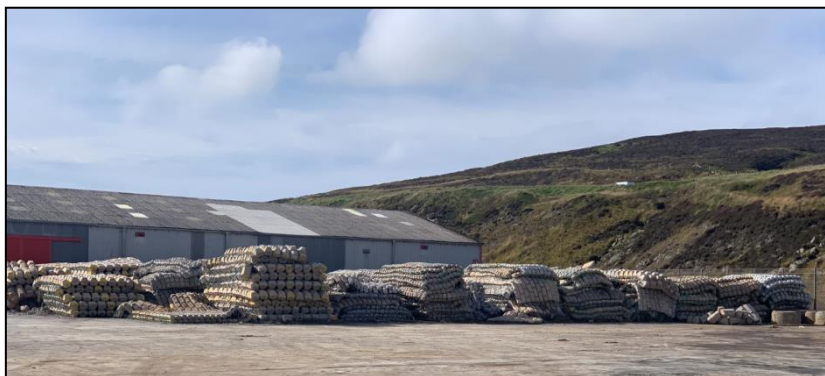
**Mattresses Recovered from Osprey, Merlin and Dunlin**

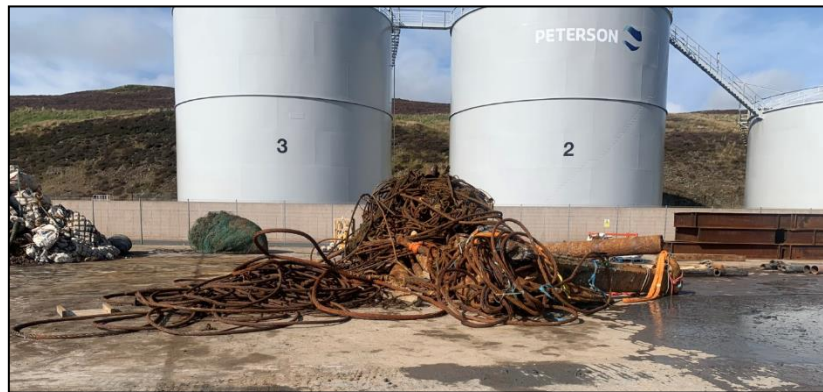
**Wire Debris & Fishing Debris Recovered**

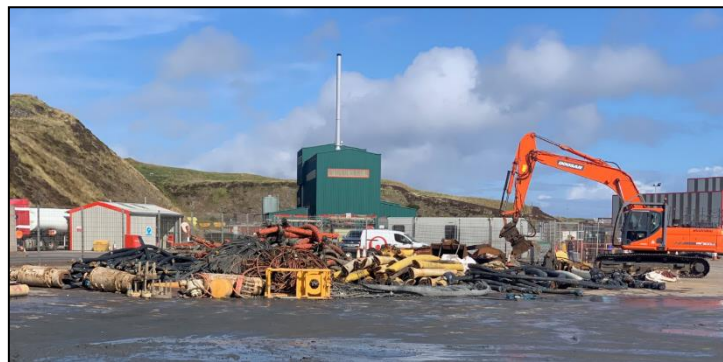
**Waste Preparation & Separation**

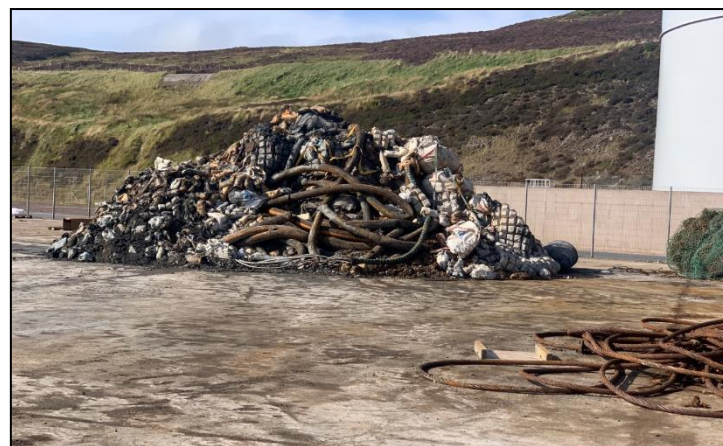
**Mixed Sand / Grout / Mattress Deposits Recovered for Landfill**  
(Note flexible hose and umbilical were not recovered by Fairfield)

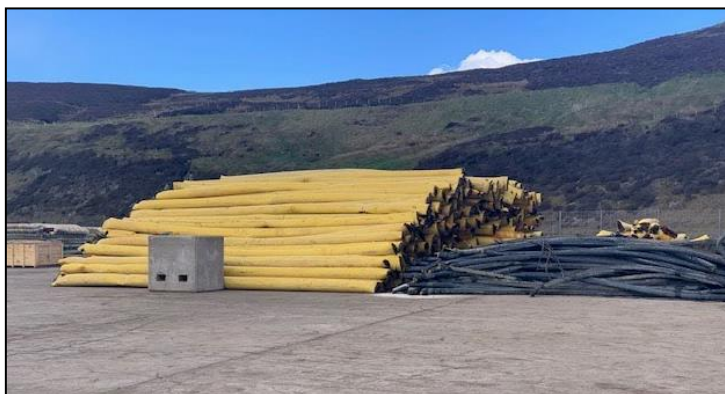
**Flexible Pipeline and Umbilicals Prepared for Transport to Recycling Facility**
