Fairfield Fagus Limited

Osprey Pipelines and Structures Decommissioning Programme Regulatory Close Out Report

Document number	FFL-DUN-OSP-HSE-01-RPT-00004-01
Revision	A3
Date	18 th Jan 2021

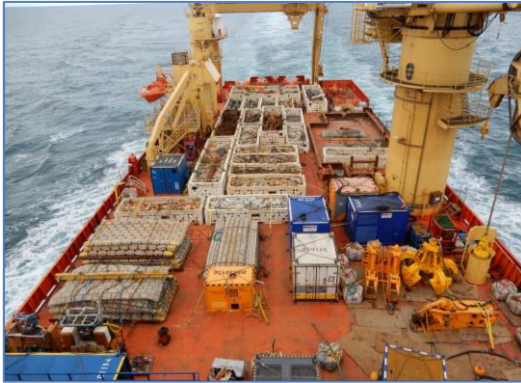
Debris Recovery

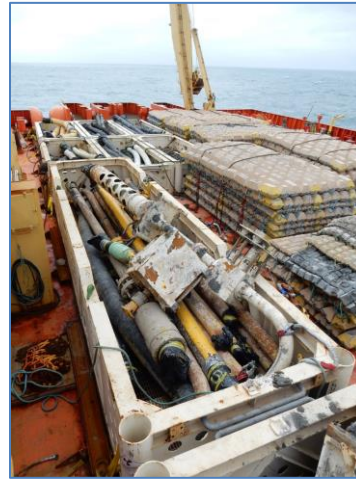
Infield Jumpers and Flowlines Recovered

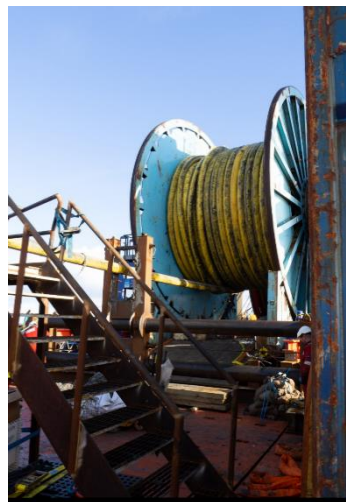
Normand Clipper Reverse Reeling 8" Water Injection Line, PL735A

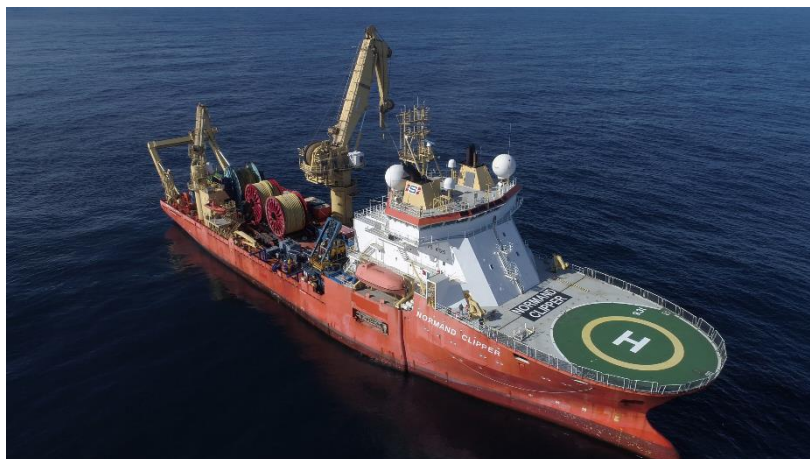
Normand Clipper Reverse Reeling

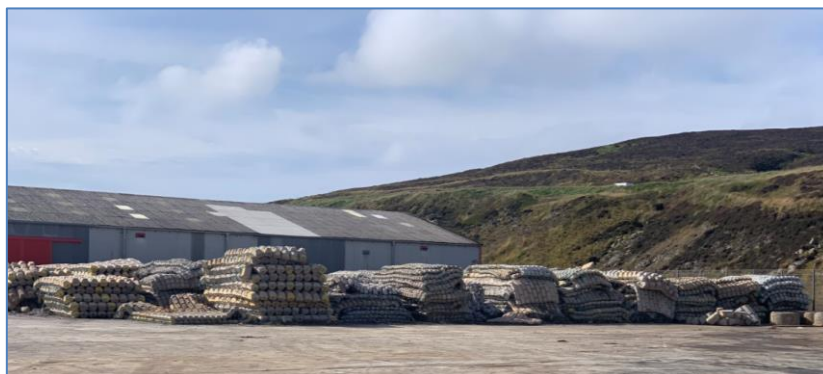
Mattresses Recovered from Osprey, Merlin and Dunlin

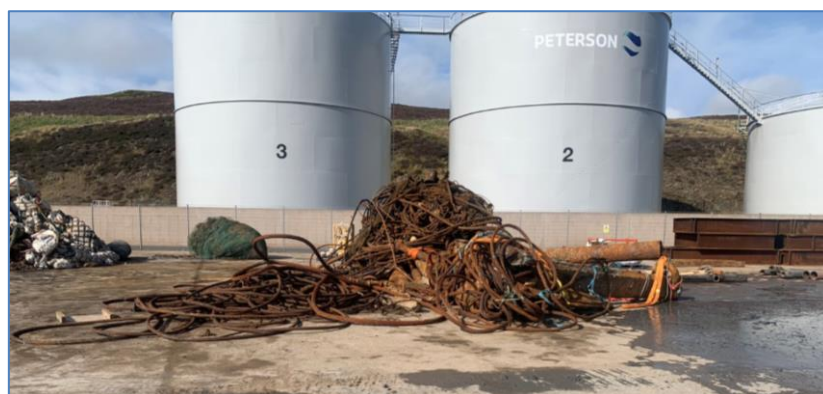
Wire Debris & Fishing Debris Recovered

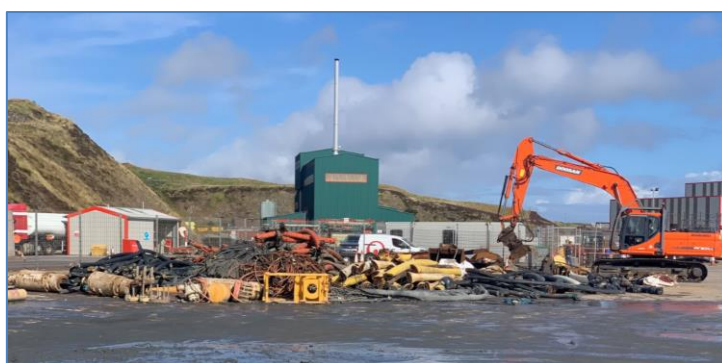
Waste Preparation & Separation

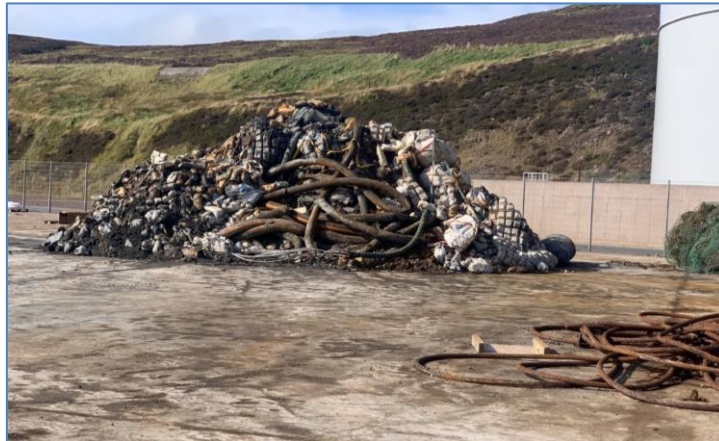
Mixed Sand / Grout / Mattress Deposits Recovered for Landfill
(Note flexible hose and umbilical were not recovered by Fairfield)

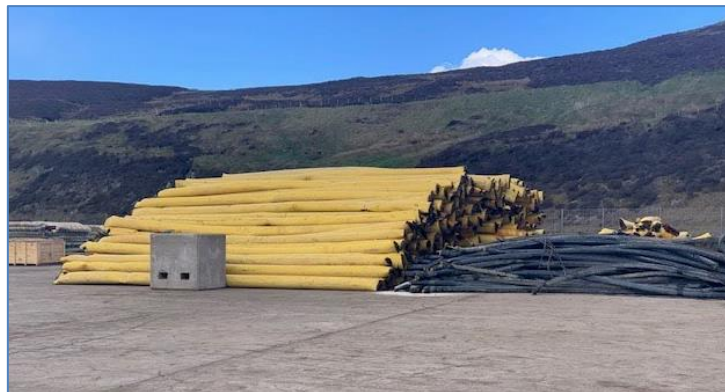
Flexible Pipeline and Umbilicals Prepared for Transport to Recycling Facility
